INSPECTION AND EVALUATION OF DAM AFTER SERIAL EARTHQUAKE

Inspection of Gegurik Dam

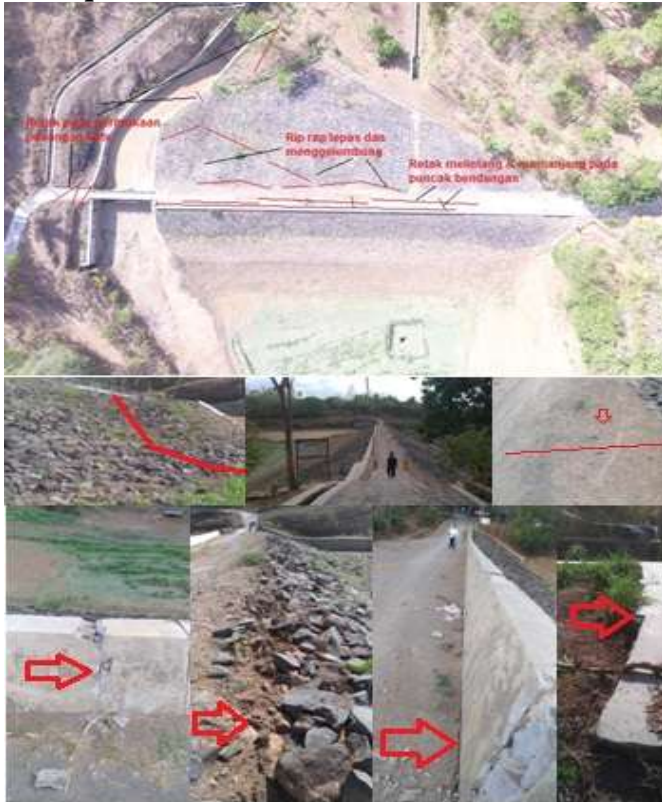
Figure 5 the Gegurik dam after the earthquake

The Gegurik Dam is located 10-20 km from the epicenter of the first strong earthquake on 29 July 2018 with a magnitude of Mw 6.4. During the earthquake, the Gegurik dam was empty. Because water collected during the previous rainy season has been used for irrigation supply. After being rocked by 3 consecutive strong earthquakes on July 29, August 5 and August 9 with the magnitudes of Mw 6.4, Mw 7.0, and Mw 6.2; longitudinal cracks and transverse were found on the top of the Gegurik Dam with widths ranges from 3 to 5 mm, the parapet was stretched around 3 mm, and the rip-rap was torn. Figure 5 shows the Gegurik dam after the earthquake.

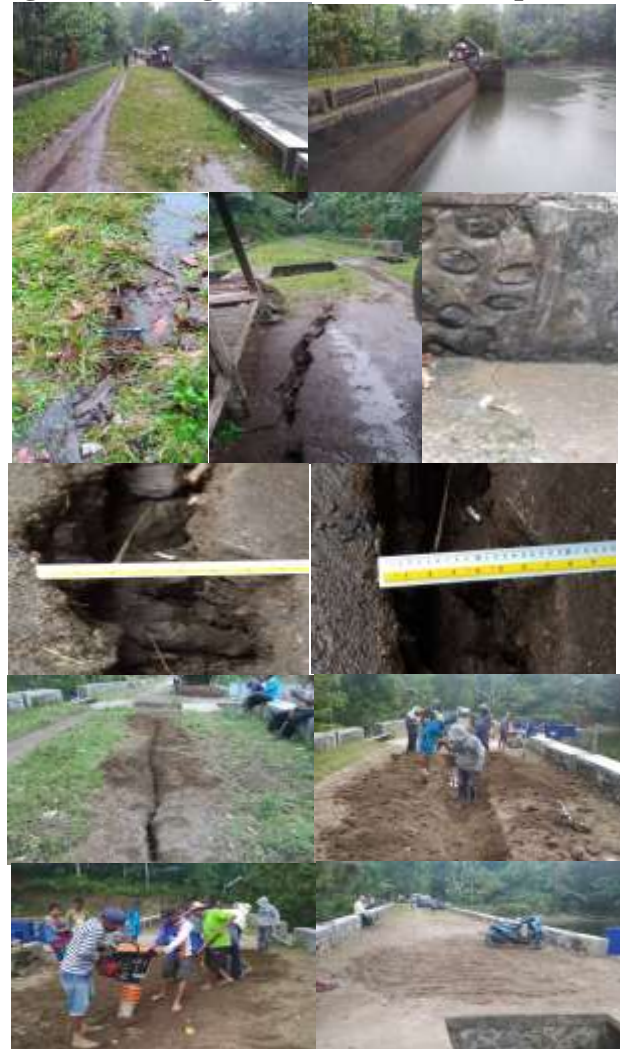
Figure 6 the Jago dam after the earthquake

Jago Dam is located 30-40 km from the epicenter of the first strong earthquake on July 29, 2018. During the earthquake, the Jago dam is full of water. The results of inspections carried out on August 16, 2018 showed that there were some cracks on the top of the dam with widths range from 10 to 170 mm. Uncontrolled seepage occurred on the downstream of embankment. Figure 6 shows photographs of the Jago dam after the earthquake.

- a. Jago Dam with a height of 15 meters is located in the range of 30-40 km from the epicenter. This dam experienced a crack of 17 cm until the third earthquake on August 5, 2018, this crack enlarged to 20 cm due to a large earthquake on August 19, 2018.
- b. Pandanduri Dam, 42 meters high, is located at a distance of 40-50 km from the epicenter. This dam did not experience a crack at the top of the dam, but it has not been measured whether there was a decrease in the dam's peak during the inspection.

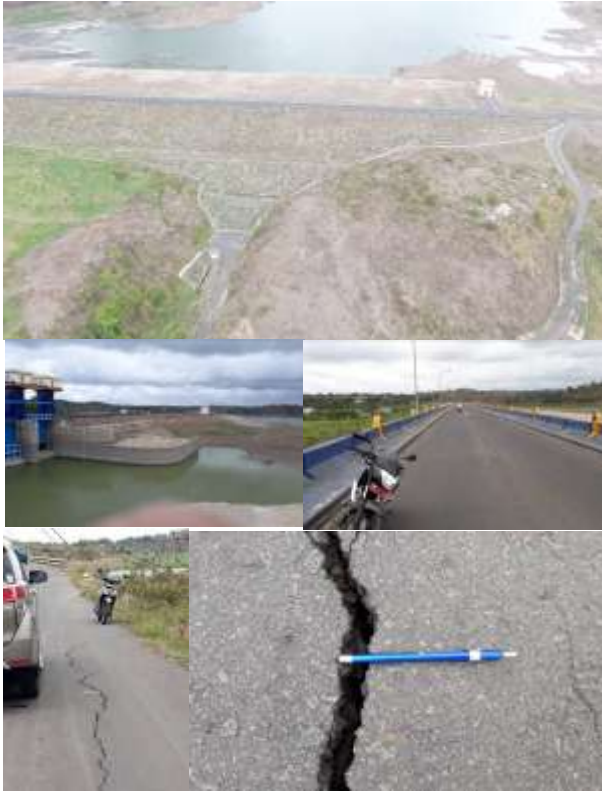
Figure 7 the Pandanduri dam after the earthquake

Pandanduri Dam is located 40-50 km from the epicenter of the first strong earthquake. During the earthquake, the Pandanduri dam is filled of water at a low water level. The results of inspections conducted on August 16, 2018 indicate that there was a longitudinal crack on the access road. The road is on the saddle dam of the Pandanduri dam. Figure 7 shows the Pandanduri dam after being shaken by the earthquake. Figure 8 shows the inspection on hydromechanics of Pandanduri Dam. Figure 9 shows pore water pressure in the core zone of Pandan Duri dam at station 650. Figure 10 shows settlements in the Pandanduri core zone at each layer's elevation at station 660 and reservoir water level. Figure 11 show the seepage discharge read in the V-notch gauge.

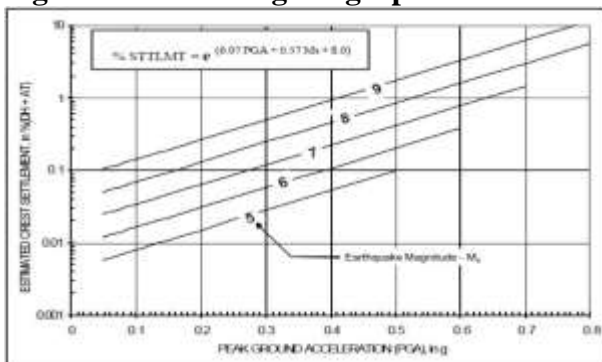
Figure 12 the Swaisgood graph

Figure 12 shows the graph of the relationship between the estimated amount of settlement at the peak of the dam with the PGA value at the dam that was rocked by the earthquake. Based on the graph, the estimation of settlements is shown below

$$\begin{aligned}
 \text{Settlement of Jago Dam} &= (0.015 + 0.025 + 0.017 + 0.021)\% \times \text{the height of the Dam} \\
 &= 0.078 \% \times \text{the height of Jago Dam} \\
 &= 0.078 \% \times 1,500 \text{ cm} \\
 &= 1.170 \text{ cm}
 \end{aligned}$$

$$\begin{aligned}
 \text{Settlement of Pandanduri Dam} &= (0.015 + 0.025 + 0.017 + 0.021)\% \times \text{the height of the Dam} \\
 &= 0.078 \% \times \text{the height of the Dam} \\
 &= 0.078 \% \times 4,200 \text{ cm} \\
 &= 3.276 \text{ cm}
 \end{aligned}$$

-
- f. The height of dam has to be refixed.
