WATERWALL TUBE BOILER DAMAGE ANALYSIS IN A 150 MW STEAM POWER PLANT

Lugantha Perkasa¹⁾, Agung Mataram²⁾ & Irsyadi Yani³⁾

^{1,2,3}Mechanical Engineering, Sriwijaya University

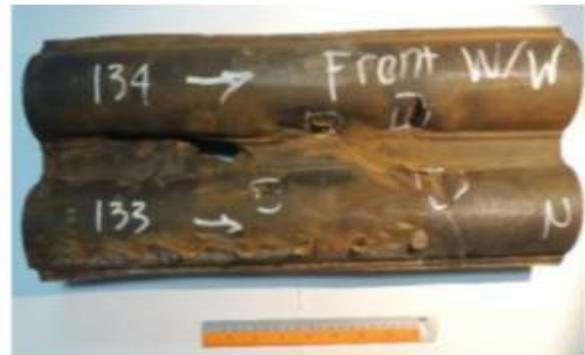
Figure 3. Waterwall Tube Boiler

Figure 3. Below is the material used in the research in the form of a waterwall tube cut in a CFB (Circulating Fluidized Bed) boiler at a steam power plant in South Sumatra that has failed. Prior to the testing process, the material will be subjected to a size reduction process using a wire cut machine.

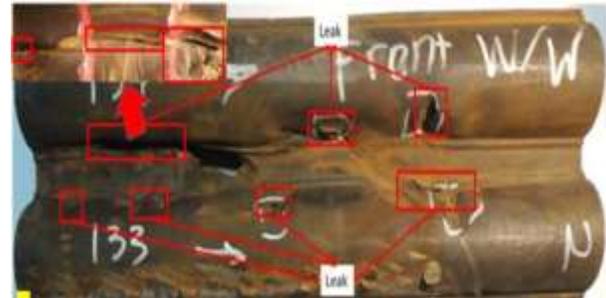
Figure 6. Indication of leakage of boiler tube waterwall

Figure 6 below is a part of the boiler tube waterwall that has failed and which will be carried out a microstructure analysis

Based on Figure 6, the leak is clearly indicated on the boiler tube. Most of the waterwall tube leakage comes from the welded joints between the plate and tube / tube. Leakage can also be observed from the outer diameter and the inner diameter of the tube as shown in Figure 7b and Figure 7c. Whereas in Figure 7a, you can see the erosion path in the waterwall tube that is leaking and the direction of the erosion comes from the position of the waterwall tube boiler which is leaking.

Based on figures 6 and 7 above, it can be observed that the inner surface of the boiler tube waterwall has no crust and no signs of erosion. However, other leaks are caused by thinning walls due to erosion. This thinning of the tube walls is caused by cracks that open causing the discharge of high velocity fluids to hit the surrounding surface creating erosion failure.

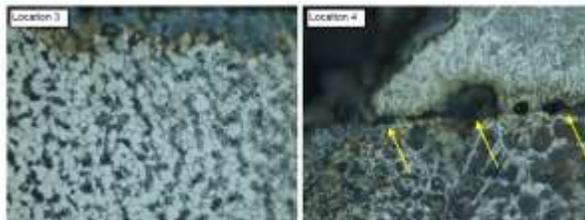
Figure 12. Micro Structure of Water Wall Tube 1 at locations 3 and 4 with a magnification of 500X.

Figure 12 shows the microstructure of the weld joint. The lack of fusion in the side wall of the boiler tube waterwall weld connection has

the potential to be the cause of the initial crack or the beginning of the crack. Under the influence of cyclic loads such as cyclic thermal, this fusion deficiency can propagate if the waterwall tube boiler is exhausted.

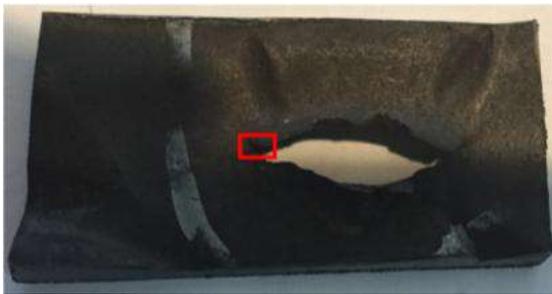
Figure 15. SEM test specimens for boiler tube waterwall

Scanning Electron Microscopy (SEM) observations were taken on the surface area of the waterwall tube boiler leak fracture as shown in Figure 15.

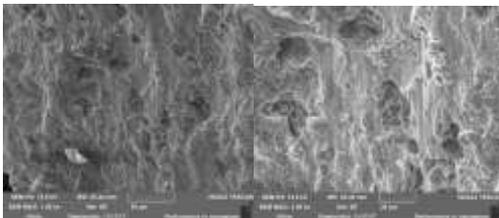
Figure 16. SEM observations of waterwall tube with 1000X and 2000X magnification

The surface in Figure 16 is covered by oxides due to corrosion. A little indication of dimple was found under observation with 2000X magnification. Dimple in tube failure usually associated by thinning rupture occurred on the tube. EDS analysis was not performed due to lack of corrosion product found on the surface of area of failure.
